**USAAMRDL TECHNICAL REPORT 72-47**

**EXPENDABLE MAIN ROTOR BLADE STUDY**

CONTRACT DAAJ02-71-C-0046  
SIKORSKY AIRCRAFT  
DIVISION OF UNITED AIRCRAFT CORPORATION  
STRATFORD, CONNECTICUT

Task 1F162205A11901  
Contract DAAJ02-71-C-0046  
USAAMRDL Technical Report 72-47  
April 1973

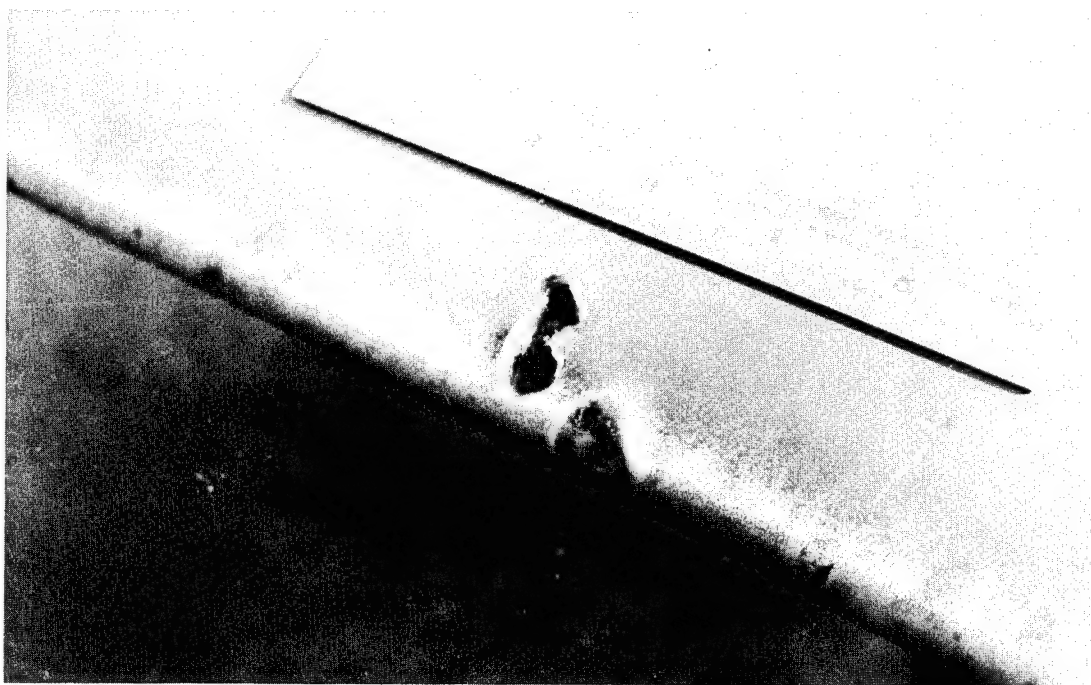
Figure 51. Blade Dent Damage.

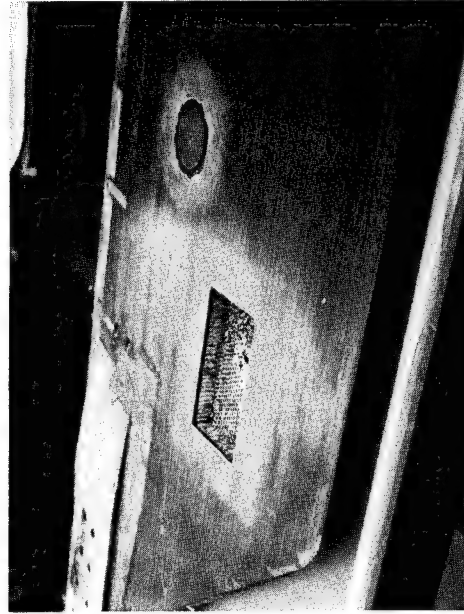
Figure 76. Plug in Place.

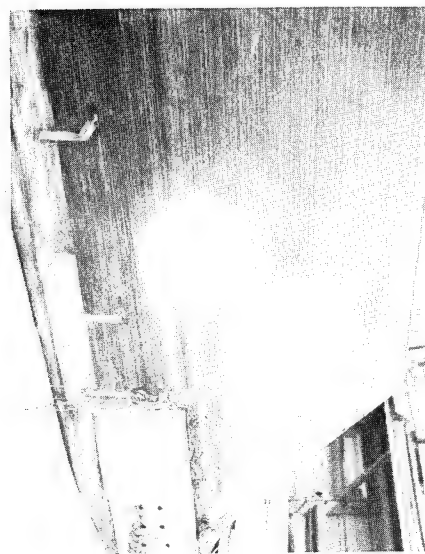
Figure 84. Finished Repair.

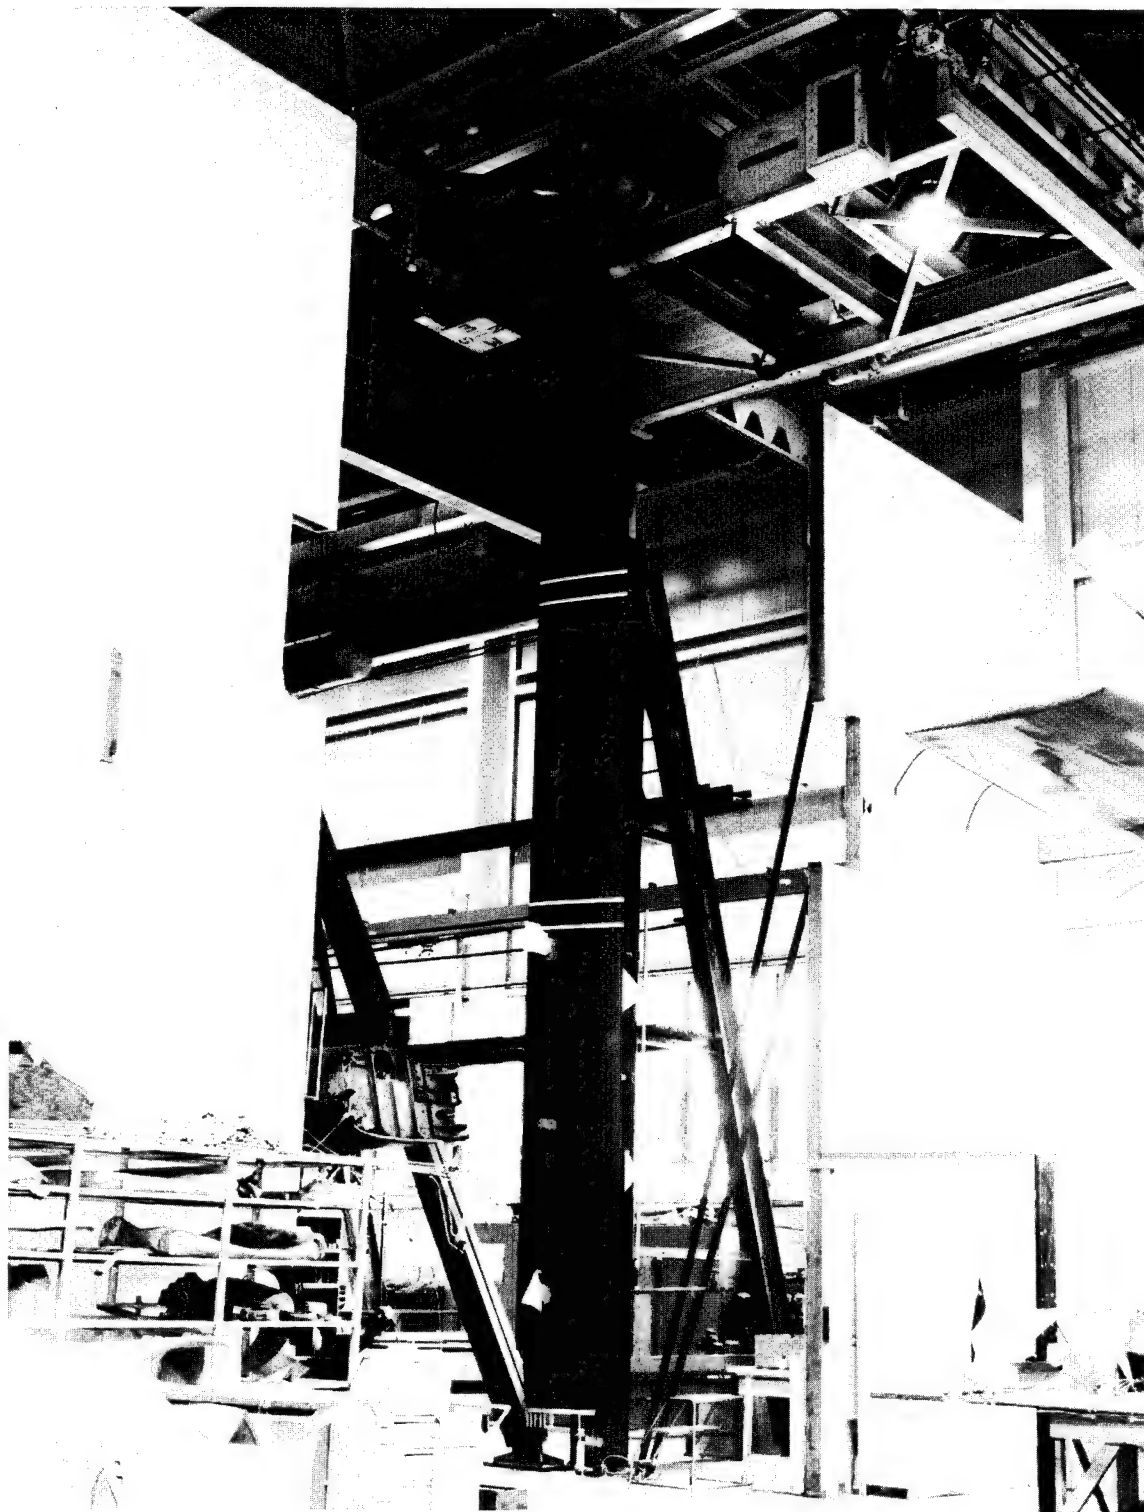
Figure 94. Static Rap Test For Blade Frequency.
